FUKUSHIMA 11

SIMPLYINFO.ORG
11TH ANNIVERSARY REPORT
MARCH 2023

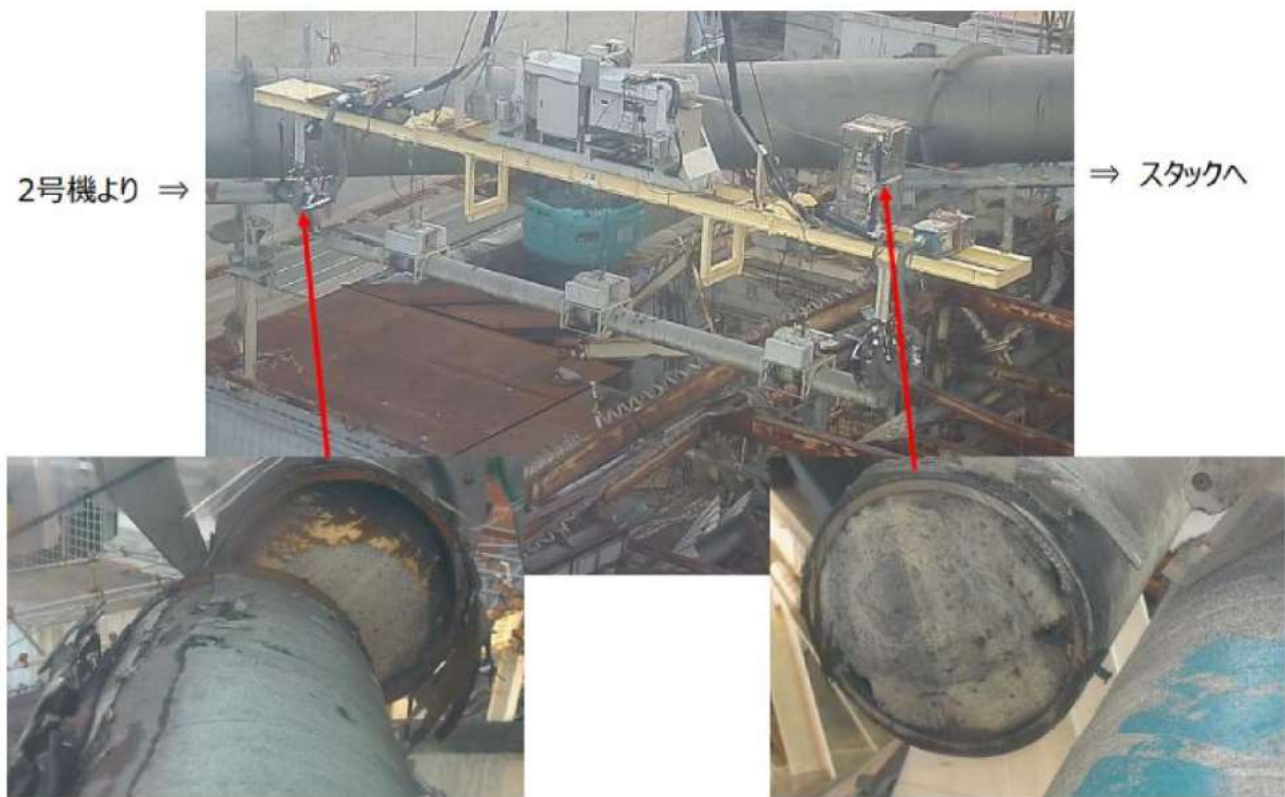
Limited work around the plant has taken place in the last year except for this piece of significant work, the removal of the unit 1-2 Standby Gas Treatment System piping. This is to remove the vent piping from units 1 and 2 as it routes to the shared vent tower.

The area has been of concern due to the high radiation levels and the presence of small radioactive fuel particles in the pipes. Sections have been filled with expanding foam before being cut and removed. (7)

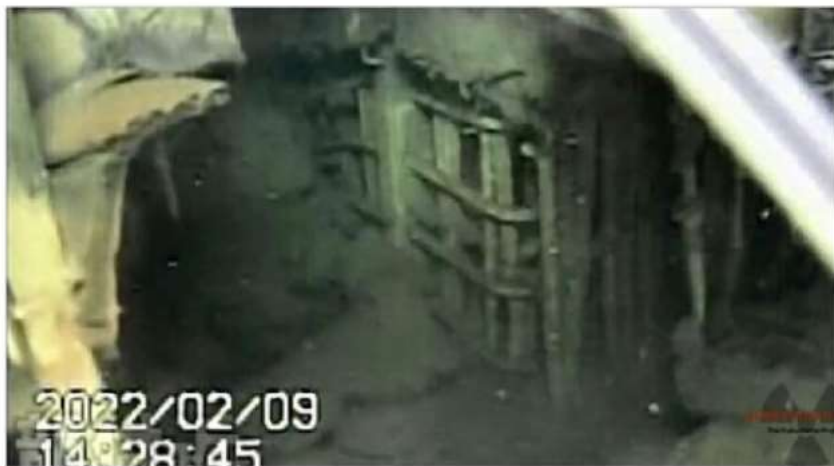
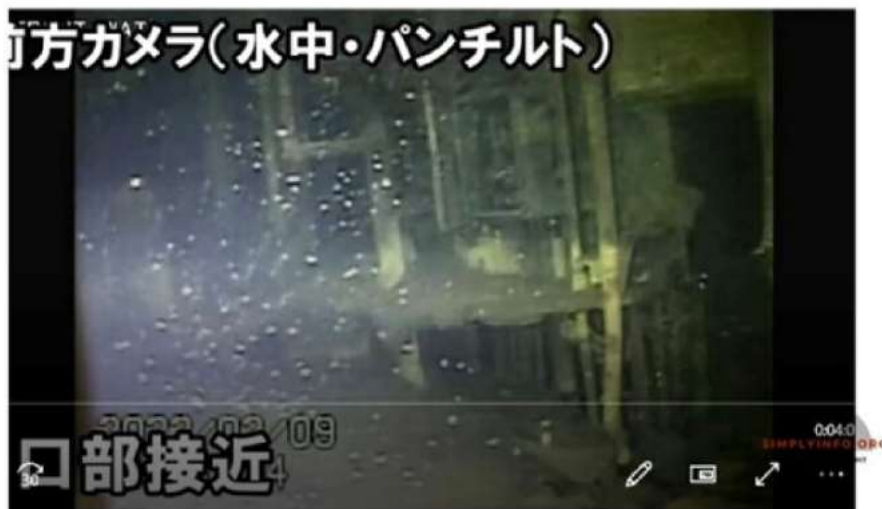
More recent admissions from TEPCO and the parties working to inspect the failed reactors confirm what we already knew. In February of 2022, TEPCO released initial images from the unit 1 containment and pedestal inspections. These showed the concrete of the reactor pedestal base had been melted or otherwise destroyed leaving some warped rebar remaining.

The view inside the pedestal doorway showed a debris pile that appeared to be about 5 feet tall. Our initial estimates of the volume of fuel debris inside the pedestal did not account for all of the concrete and other materials the fuel debris consumed and added to the fuel debris pile in the pedestal. (20)

The two images above show the unit 1 pedestal doorway. Distinct visuals of the destroyed concrete and remaining rebar are evident. This damage goes up approximately 4 feet of the roughly 6-foot-high entryway into the pedestal.

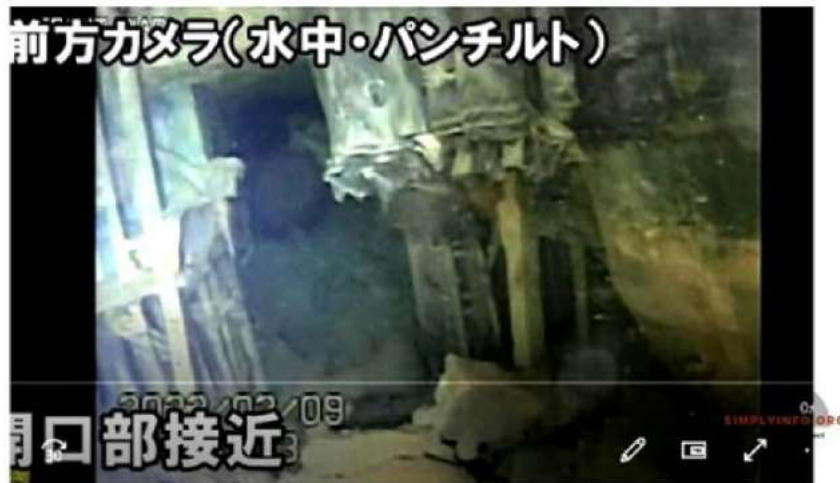
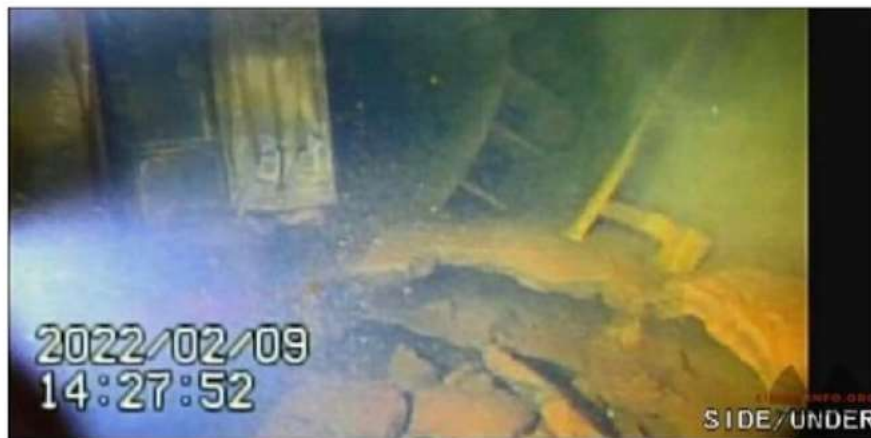
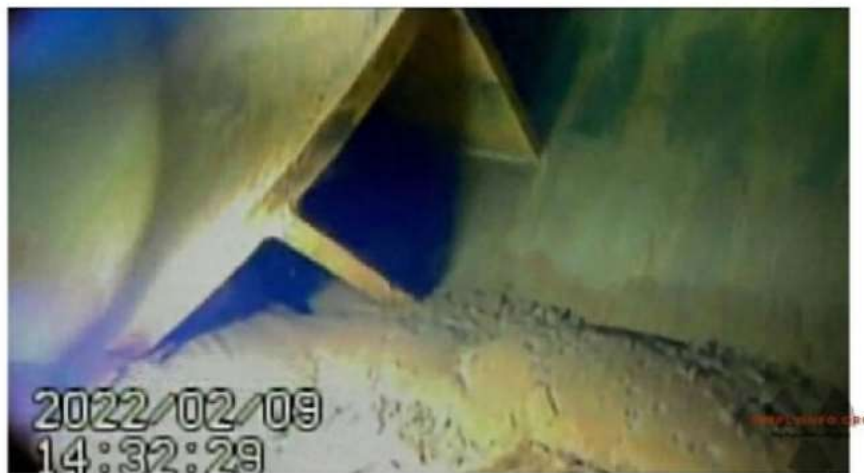
The top image shows the damaged entryway into the pedestal and a debris pile inside that exceeds the height of the doorway. The remaining images show solidified fuel debris reaching about 1/4 of the way up the jet deflectors of the downcomer tubes, confirming molten fuel flowed into the suppression chamber and out of containment.

These reports confirmed what we have stated for years. That the meltdown at unit 1 was a massively destructive event. All the fuel inside unit 1 has melted and a significant amount has escaped containment through various means. (21)

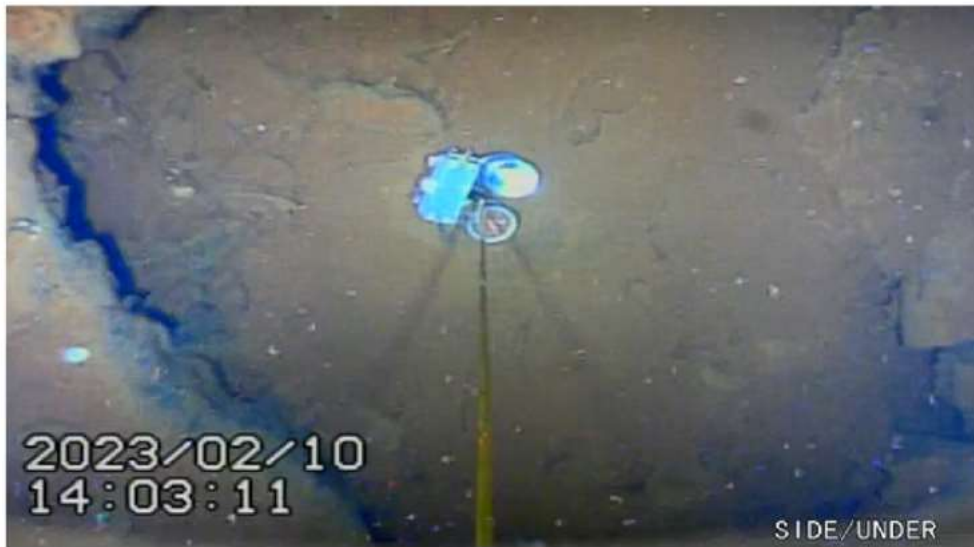
In February 2023 TEPCO completed work to sample the fuel debris sediments on the containment floor of unit 1. The layered formerly molten strata can be seen in the photo above.

These sediment layers were initially a curiosity. TEPCO provided photos of what looked like deep layers of sand on the containment floor from some previous inspections.

floor would mean there was massive destruction of the pedestal, and potentially the concrete bio-shield.

TEPCO's newer inspections confirm that to be true. What isn't currently known is the condition of the pedestal further up from the containment floor. If there is damage further up it would confirm even more instability of the reactor vessel and internal containment structures.

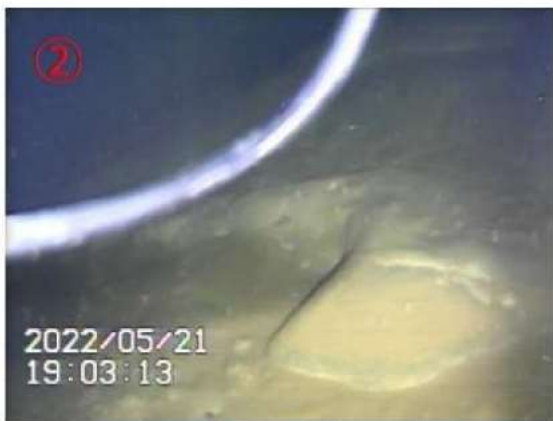
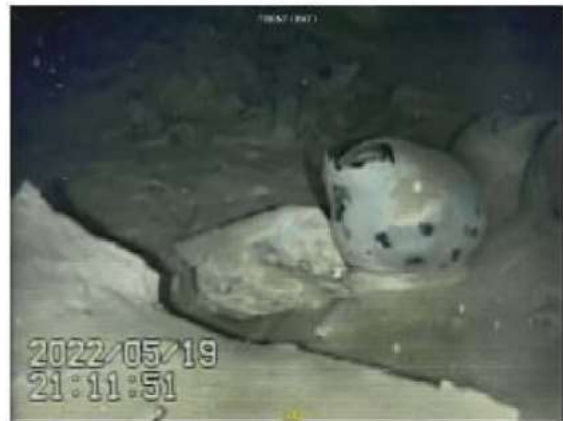
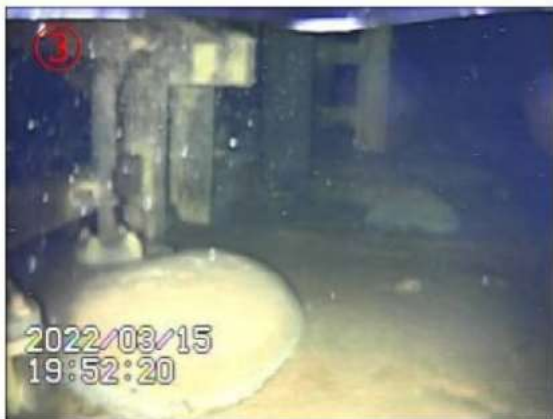
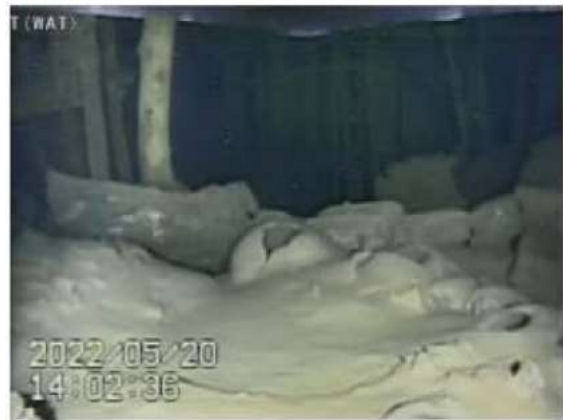
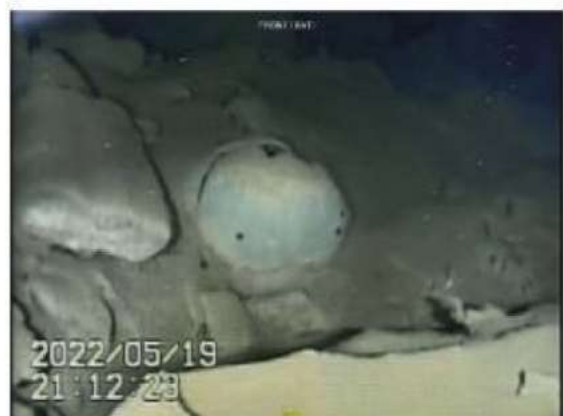
In March of 2022, additional containment inspections inside unit 1's containment found solidified bulges or large bubbles in the cooled fuel debris on the floor. Each of these were found just outside of the perimeter of the pedestal. This appears to be a new not previously seen phenomenon. (22)

These "hollow shell" formations were also found in the corium debris bed. These were found near the pedestal door.

TEPCO speculated possibly something that fell from above caused them but at this point do not know what they are or what caused their formation.

Stitched-together photos of the layered corium inside unit 1 were included in the TEPCO report. This odd phenomenon shows two thin layers of solidified fuel debris with a clear gap between the layers. Trapped gases are known to bubble through molten corium. The extent of some of the findings like these two distant layers seems to defy the trapped gas theory.

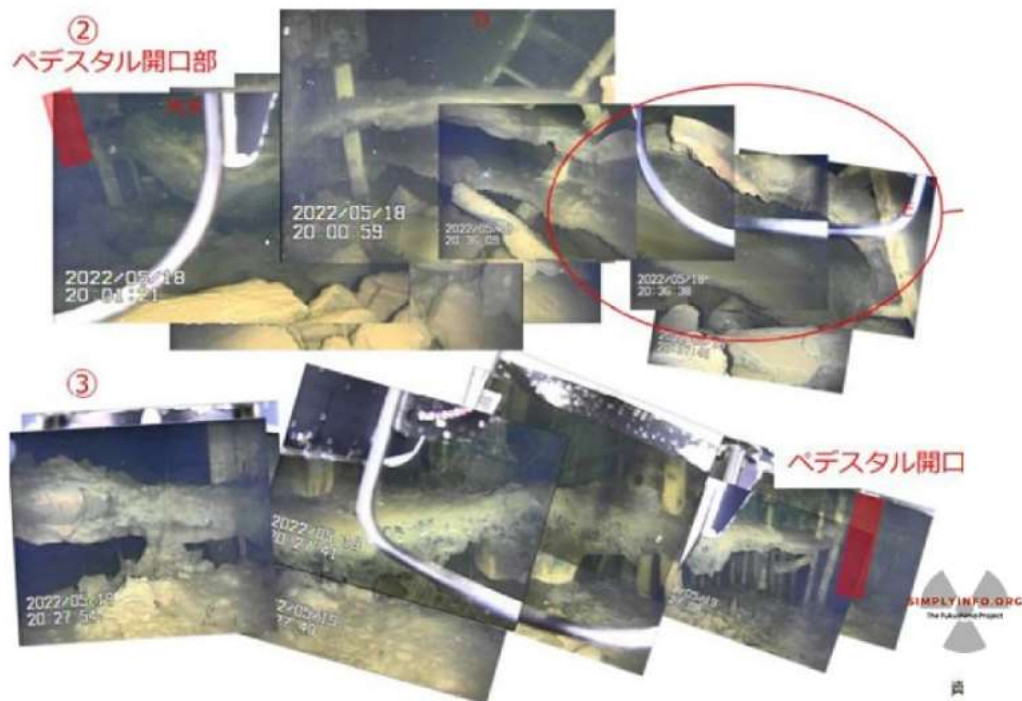
significant portion of the pedestal base as seen in the inspection photos. (23) Engineers interviewed by Asahi Shimbun raised concerns about the stability of the reactor and related components with the pedestal so significantly damaged. (24)

In 2022 Asahi Shimbun confirmed what we already knew but TEPCO had been avoiding stating. The concrete of the pedestal had melted away leaving just rebar around a

How to address this concerning instability has not been documented as a roadmap item and to date, there have been no public-facing efforts to research a solution.

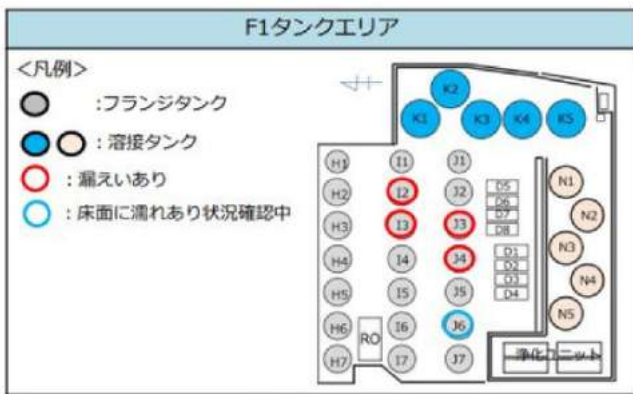
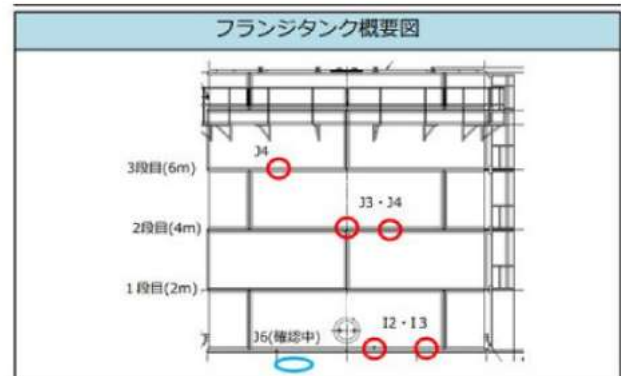
The bolt together tanks used to hold contaminated water as a stop-gap measure in 2011 are still in use at the plant site. TEPCO assured the public that they would drain and decommission all these tanks on site, yet many are still in use. These tanks had a 3-5-year life span before the gaskets between the tank sections were expected to fail and leak. 12 years later they are still in use. (36)
