FUKUSHIMA 11

SIMPLYINFO.ORG
11TH ANNIVERSARY REPORT
MARCH 2023

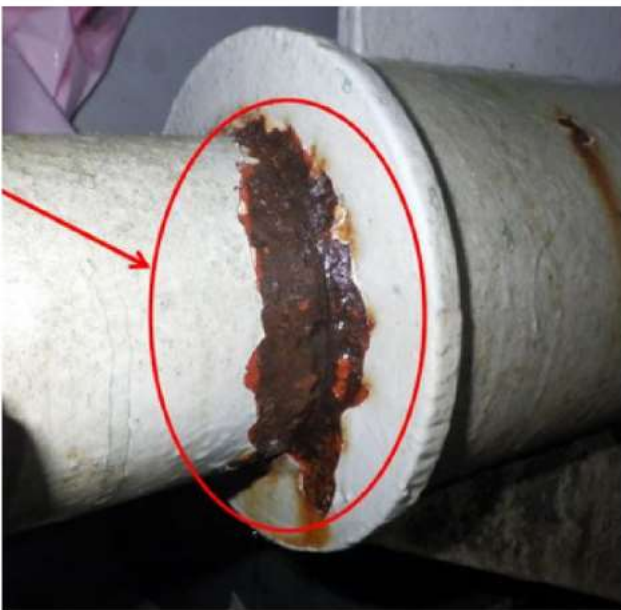
The plant cleanup rolls into another decade, as hundreds of unmaintained systems at the plant site start to show decay. So far these have been trivial in nature, but they show the widespread degradation of the plant site. What is happening with these systems is likely also happening to systems that can have serious consequences when they fail. This corroded pipe (below) containing the oil for a power transformer near unit 3 began to leak oil. (3)

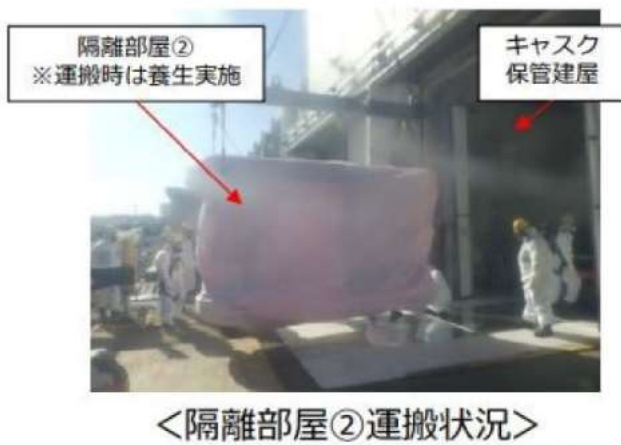
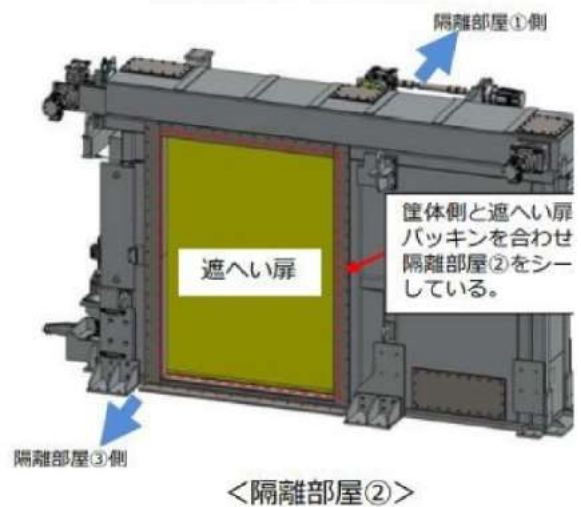
Workers have begun installing pieces of the hot cell structure needed to contain the fuel debris removal arm and remove canisters of collected fuel debris. (22)

Image: TEPCO. Installation of the hot cell components and a diagram of the same for unit 2.

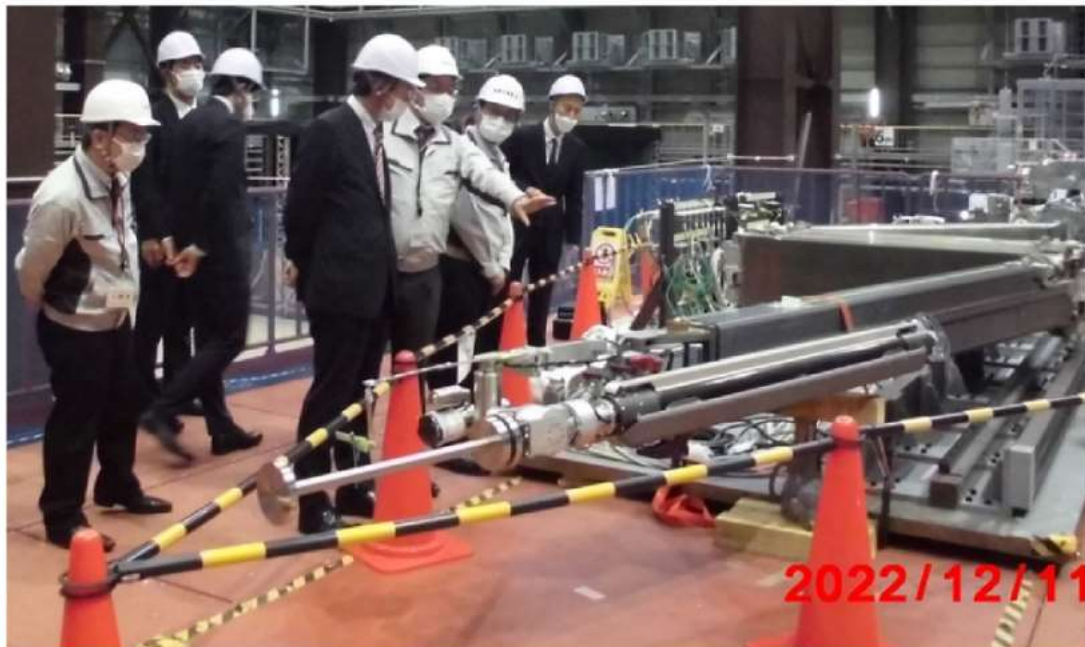
Problems with the performance of the robotic arm for fuel debris removal have bumped the start of those efforts until fall of 2023 (25)

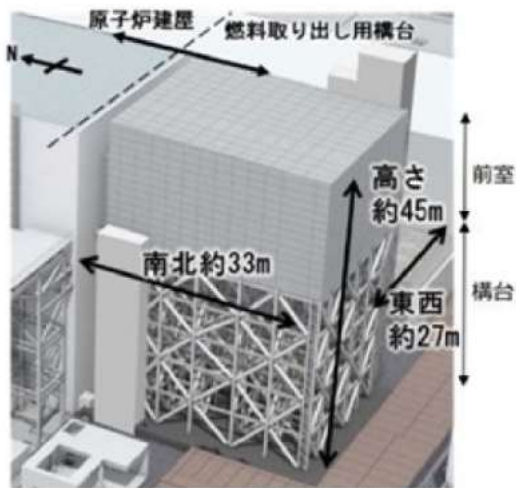
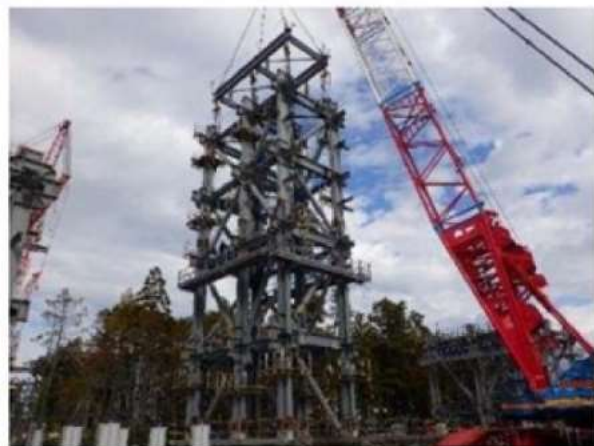
Work has continued to prepare unit 2 for eventual spent fuel removal. Efforts to dismantle structures inside the refueling floor have been underway as has work to install the new building alongside unit 2 for removing spent fuel casks. (26)

Image: Original Image TEPCO, image enhancement, SimplyInfo.org
Unit 2 external defueling building diagram and construction on site.

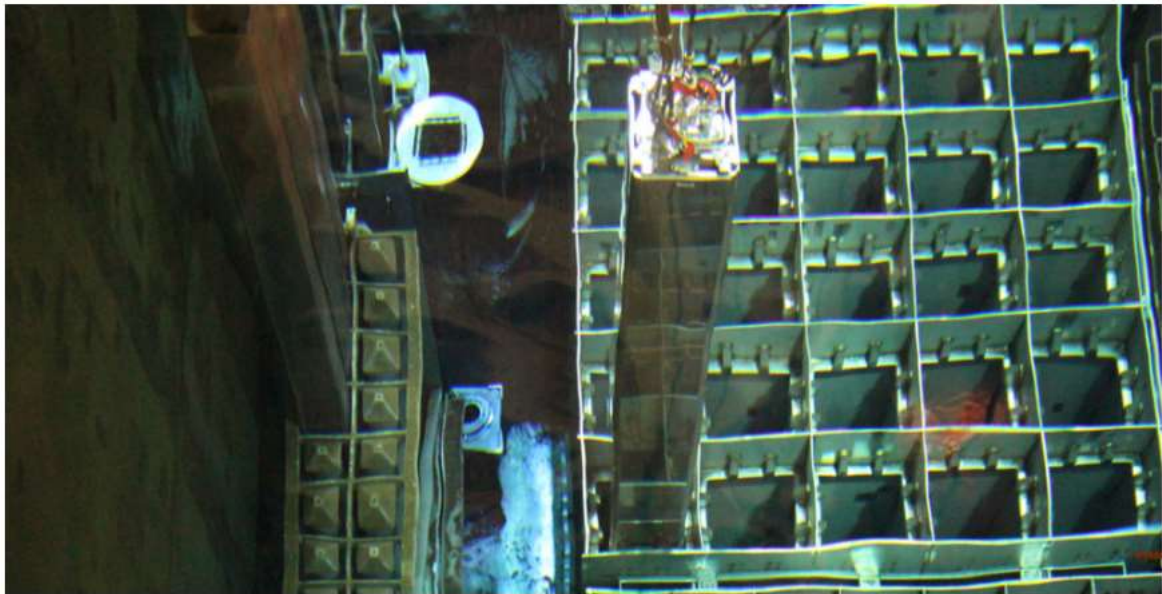
TEPCO plans to begin removing the remaining high-level debris inside the unit 3 spent fuel pool. This includes old control rods and other pieces of equipment.

All of the spent fuel has been removed. Control rods, other highly radioactive reactor components, and the fuel racks remain in the pool. (27)

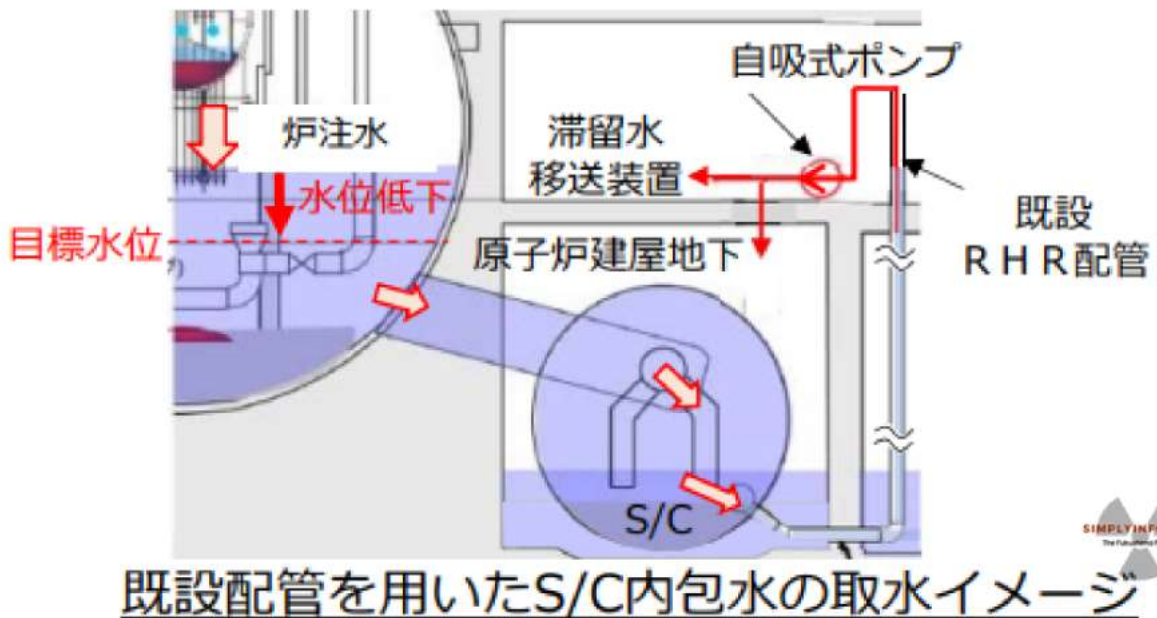
Work is underway to lower the water level in containment by drawing water out of the suppression chamber via an RHR pipe. TEPCO plans to reduce the water level below the first floor citing seismic concerns.

The level above the first floor is also where the small but known leaks of water from containment have been found. (28)
